FACILITY COMPLIANCE INSPECTION REPORT

Division of Waste Management Solid Waste Section

Date of Site Inspection: June 14, 2012 **Date of Last Inspection:** June 8, 2011

FACILITY NAME AND ADDRESS:
 Watauga County MSW Transfer Facility
 336 Landfill Road
 Boone, NC 28607

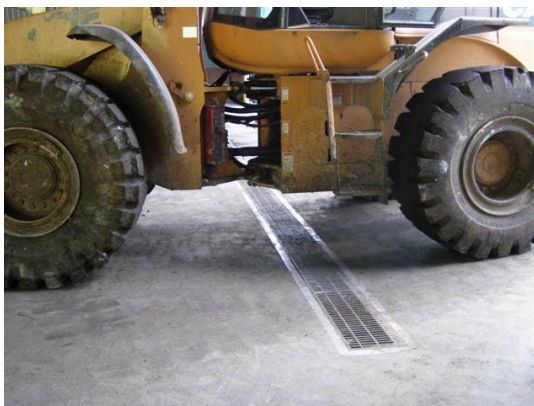
5. The transfer facility building was inspected. The tipping floor and push-walls were maintained in good condition. It was stated that the floor was washed daily. A rubber bib is utilized on the loader.
6. Wash water and leachate flows to a trench drain. The trench drain and steel grate cover appeared to be free of debris and maintained in good condition.

View of trench drain.
Photo taken by Deb Aja on 6/14/2012.

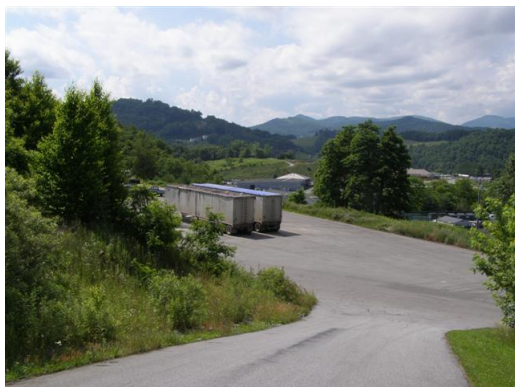
11. Transfer trailers are owned and hauled by K.R. Drenth Trucking, Inc. (KRD Trucking). Ten trailers are currently utilized for operations. County personnel move trailers on site. Loaded trailers are moved to a paved staging area between the Transfer Facility building and the Materials Recovery Facility (MRF) building. Two loaded trailers were parked in this area at the time of the inspection. The trailers were covered with tarps and the pavement underneath the trailers was dry. The trailers did not appear to be leaking.

View of loaded trailers in staging area.
Photos taken by Deb Aja on 6/14/2012.

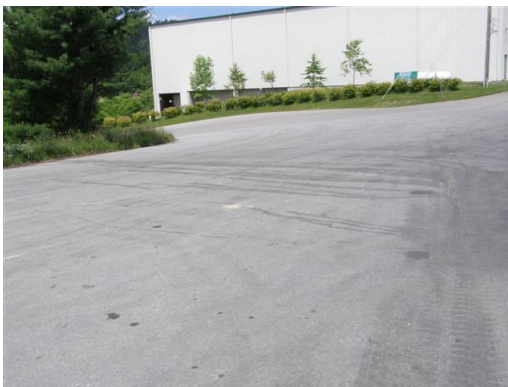
12. Stains were observed in the loaded trailer staging area. It appeared that liquids had flowed downgradient of the staging area to vegetation. Trailers should be observed to determine if they are leaking. **Liquids leaking or draining from trailers with waste would be considered leachate and must be managed. To prevent a release of leachate the staging area must not be utilized to drain liquids from loaded trailers and any leaking trailers must be repaired. To be in compliance and prevent harm to public health and the environment all leachate at the site must be properly managed and be collected by the leachate collection system.**

View of stains on pavement in staging area (transfer building in background).

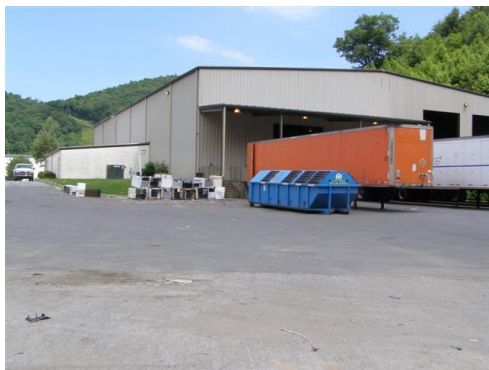
13. The white goods collection area was observed. White goods containing chlorofluorocarbon refrigerants (CFCs) were stacked next to the MRF building for extraction of CFCs. Other white goods were loaded on pavement near the glass collection area. The facility stated that they intend to install a concrete block wall in the white goods loading area similar to the walls constructed in the recycled glass bays. County personnel remove and haul the white goods to the recycler.

View of stacked white goods with CFCs (and tire loading area at MRF).
Photos taken by Deb Aja on 6/14/2012.

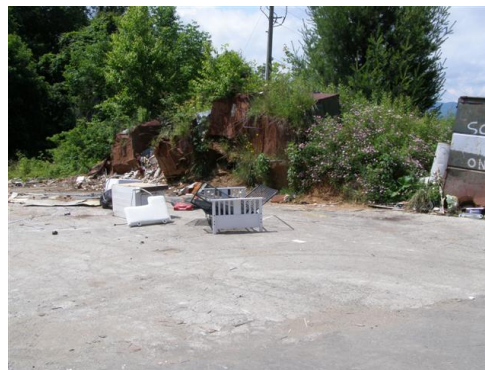
View of white goods loading area.

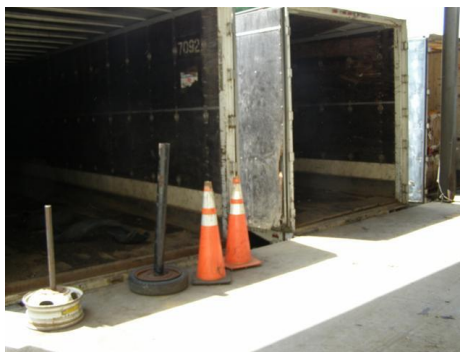
14. The tire collection area was observed. Three trailers were present and parked next to a covered loading dock and tires are always covered at the facility. County staff place tires in the trailers.

View of tire trailers in covered tire unloading area.
Photo taken by Deb Aja on 6/14/2012.
